Engineering Details

CRACKS, JOINTS & TRANSITIONS

JOINTS

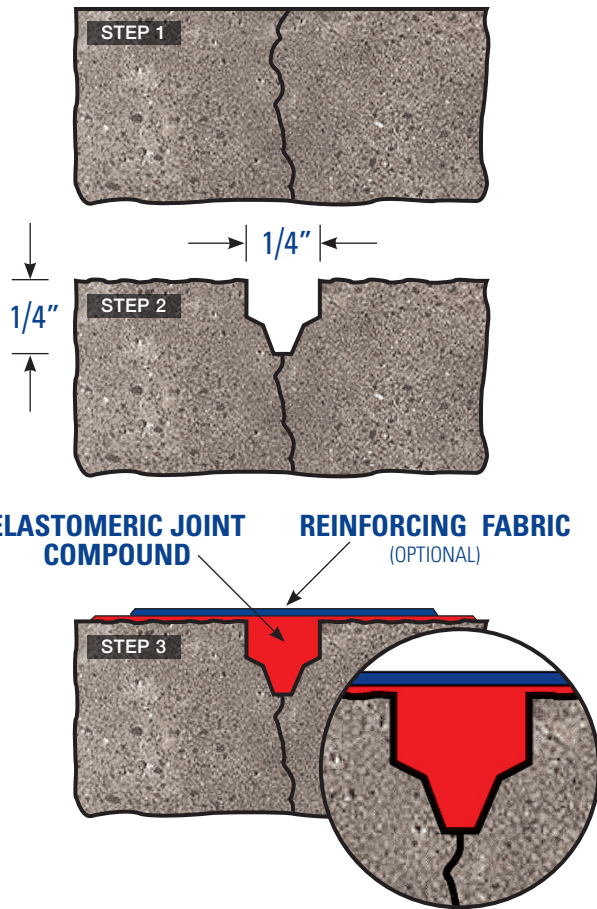
SURFACE CRACK

SURFACE CRACK RESTORATION

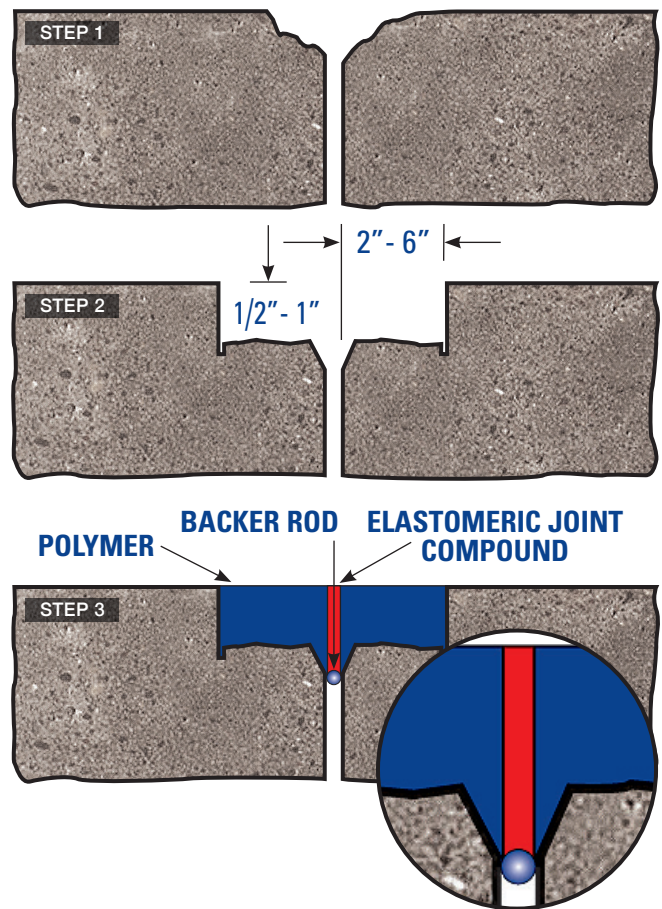
DAMAGED SHOULDER JOINT

MINOR SHOULDER JOINT RESTORATION

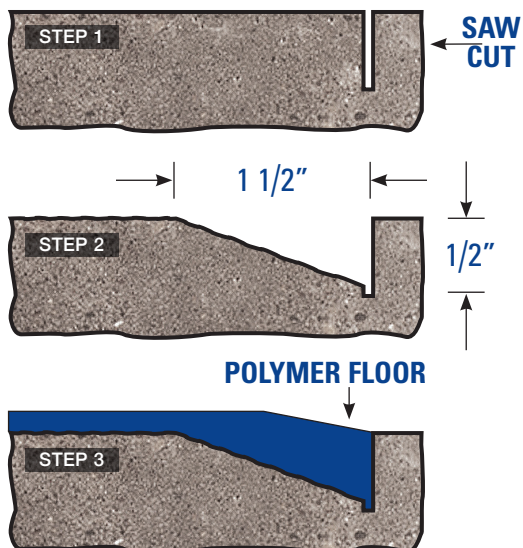
"KEY" CHASE

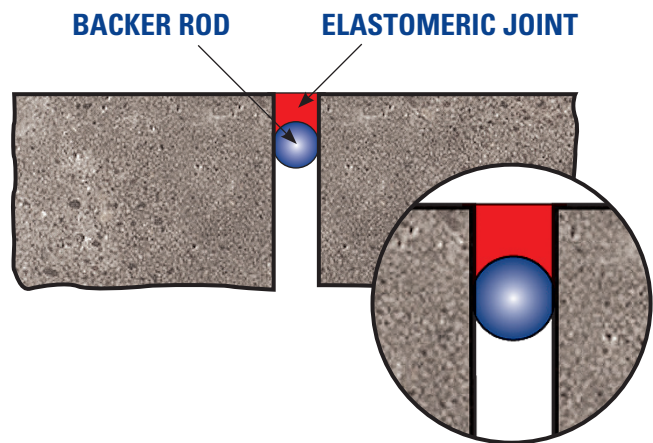
EXPANSION/ISOLATION JOINT

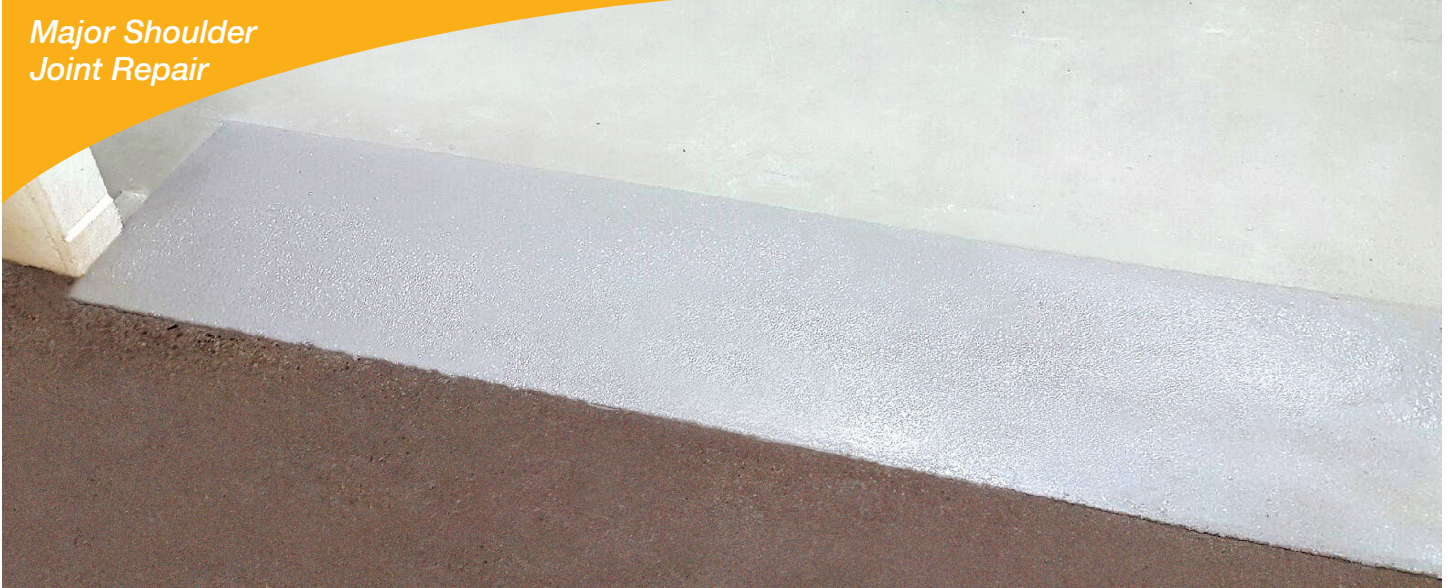
Major Shoulder Joint Repair

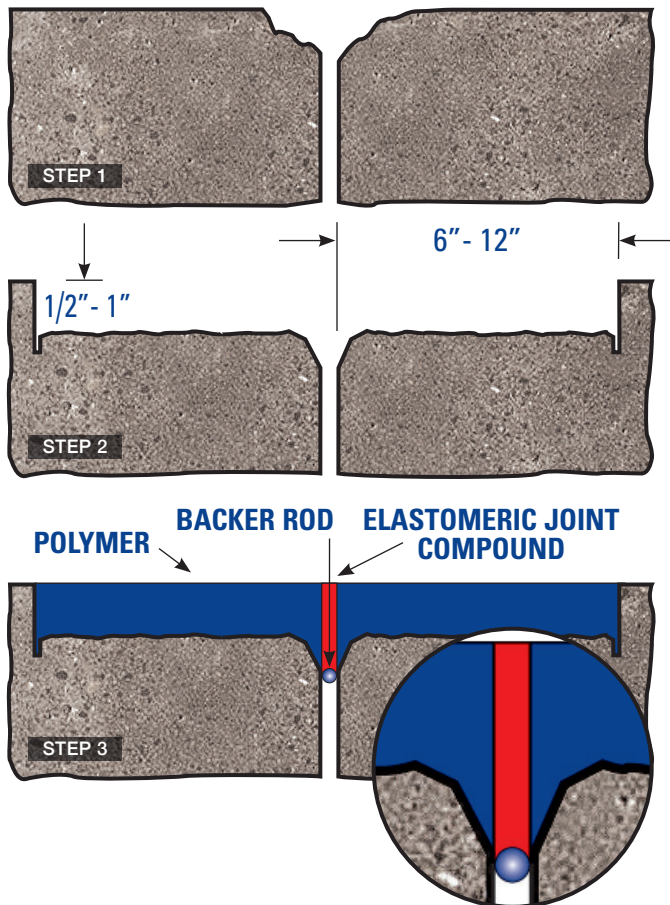
DAMAGED SHOULDER JOINT

MAJOR SHOULDER JOINT RESTORATION

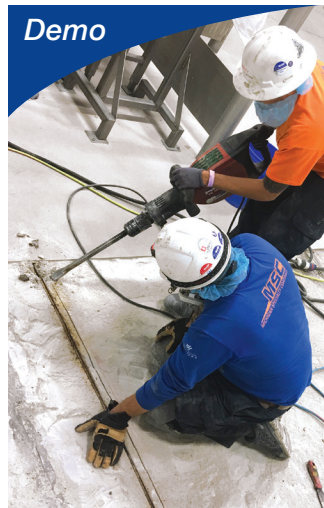
Demo

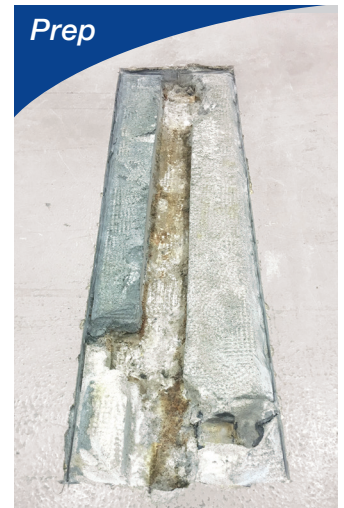
Prep

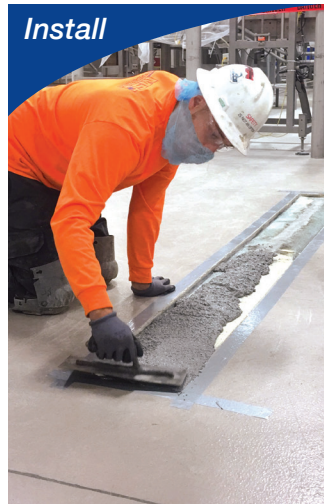
Install

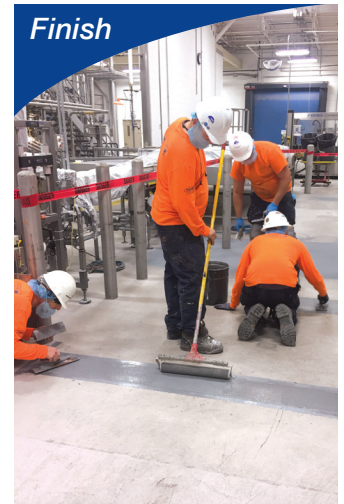
Finish
